Inspection Report Minerals Regulatory Program July 16, 2012

Mine Name: Italian Tan	Permit Number: S/007/0038		
Operator Name: Quality Building Stone	Inspection Date: July 11, 2012		
Inspector(s): Wayne Western	Time: 11:40 – 11:59 AM		
Other Participants:	Mine Status: Partially Reclaimed		
Weather Condition: Hot	Last Inspection: April 25, 2012		
Bond Renewal Date: NA	Bond Amount: \$3,000.00		
Surface Ownership: Fee	Mineral Ownership: Fee		
Last Year of Production: 2004	Acreage: 5 acres permitted most reclaimed

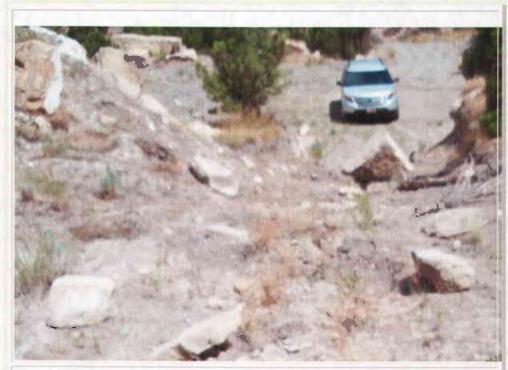
Overview of drainage

Given the nature of the site, erosion will only be controlled by vegetation or by rip rapping the entire drainage. The Permittee must seed the drainage in the fall. Given the drought conditions reseeding efforts at this time would be futile.

The Division should continue to monitor the site and make sure the vegetation is established in the drainage.

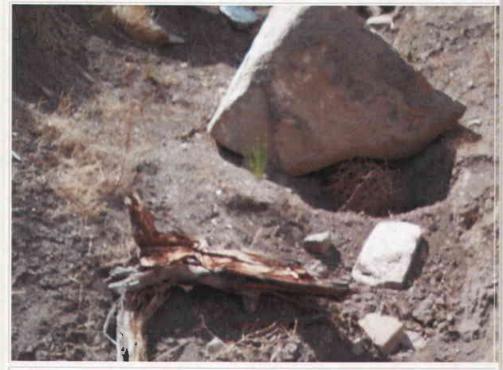
The Permittee used hand tools and rocks to stabilize the drainage. The Permittee dug several small pocks, which were approximately 12 inches in diameter and 6 inches deep. The Division would have preferred that the pocks be deeper and wider. The rocks appear to be placed to control erosion.

Pocks and rocks to control erosion

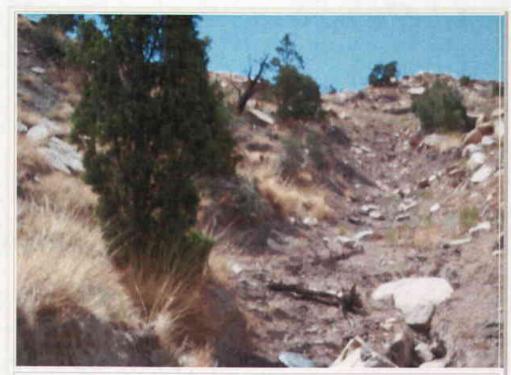
Drainage looking up drainage

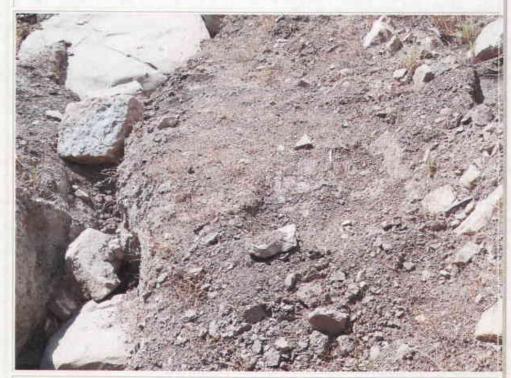
Pocking and rocks for erosion control
